Manhole Inspection Summary

Manhole # S61Q__003MH

Insp Date: **5/2/08 10:05 AM**

Location Address: **5300 Holabird Ave.**

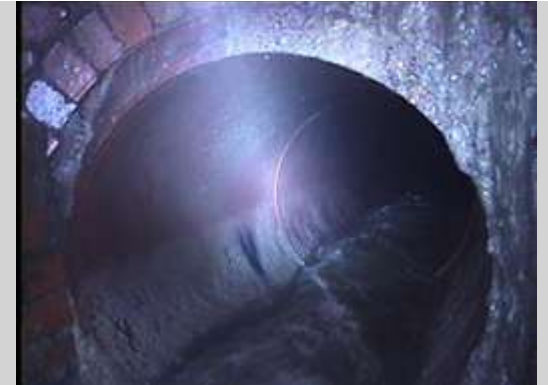
12 O'Clock Outflow

27 in. Circular Gravity Sewer
Pipe Out @ 12 O'Clock

Pipe Height: **25.2** (in.) Rod and Bar (Angled)
Pipe Material: **Clay** ☐ Pipe Lined
Invert Depth: **24.80** (ft.) Flow Characteristics: **Fast**
Deposits: ☒ None ☐ Mud ☐ Sludge ☐ Debris ☐ Grease
Silt Depth: (in.) Deposits Extent:
Infiltration: **None** Pipe Seal Cond: **Sound**

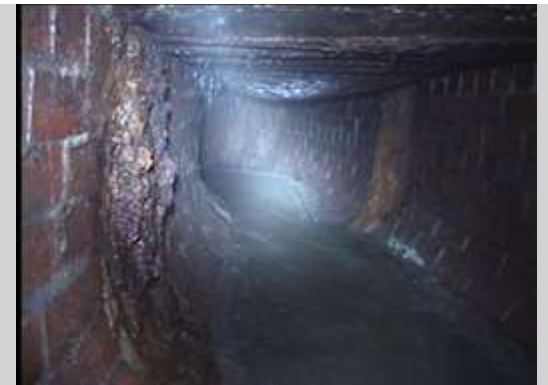
6 O'Clock Inflow

24.0 in. (w) x 24 in. (h) U-shape with flat top Gravity Sewer
Pipe In @ 6 O'Clock

Pipe Height: **25.2** (in.) Rod and Bar (Angled)
Pipe Material: **Unknown** ☐ Pipe Lined
Invert Depth: **24.25** (ft.) Flow Characteristics: **Fast**
Deposits: ☒ None ☐ Mud ☐ Sludge ☐ Debris ☐ Grease
Silt Depth: (in.) Deposits Extent:
Infiltration: **None** Pipe Seal Cond: **Sound**

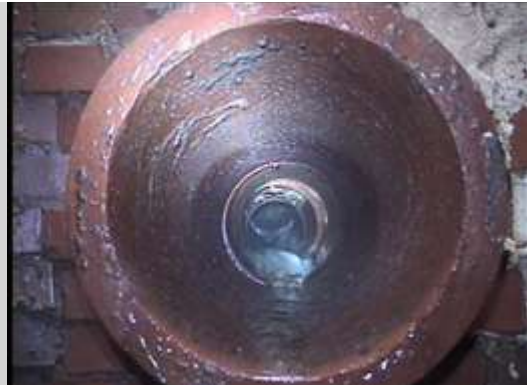
9 O'Clock Inflow

10 in. Circular Gravity Sewer

Pipe In @ 9 O'Clock

Pipe Height: **9.6** (in.) Rod and Bar (Angled)

Pipe Material: **Clay** ☐ Pipe Lined

Invert Depth: **9.42** (ft.) Flow Characteristics: **Fast**

Infiltration: **None** Pipe Seal Cond: **Sound**

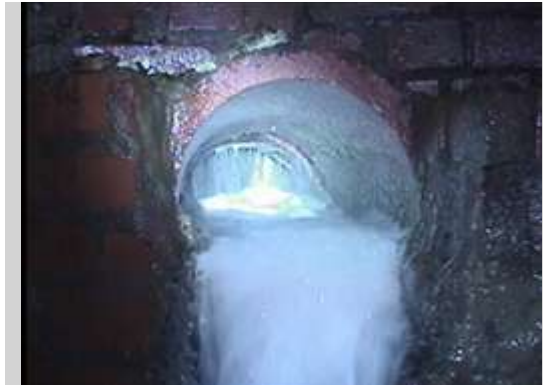
Drop In @ 9 O'Clock

Drop: **Outside** Rod and Bar

Angled: **Yes** Reading: **22.33** (ft.)

Inv Depth: **23.33** (ft.)

Drop Condition: **Open**
